**FACILITIES AUDIT, REDEVELOPMENT SCENARIOS AND FINANCIAL ANALYSIS
FOR MUNICIPAL WELLNESS INFRASTRUCTURE PROJECTS
IN THE TOWN OF HAPPY VALLEY-GOOSE BAY**

SHEPPARD CASE
ARCHITECTS INC

June 2, 2014

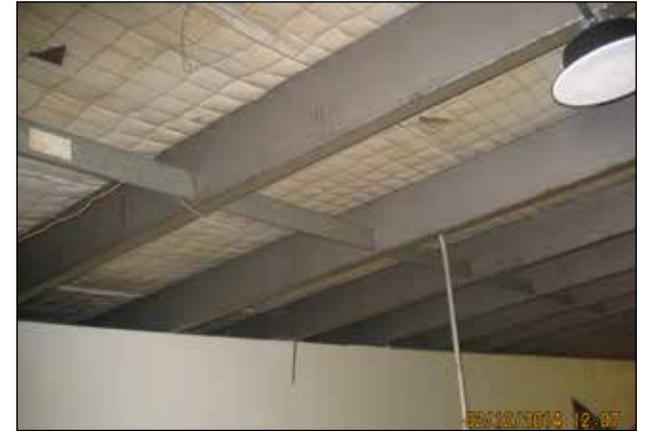
1. Typical roof purlins.

- A visual inspection of the main rigid frame and roof purlins yielded no signs of deterioration or possible failures. The purlins are braced at mid-span, which is typical for this type of construction (image 1). The purlins were checked for the 2010 snow load and yielded a new deflection limit of $L/200$. The existing rigid frames were not checked due to the complexity of the design of the frames (image 2).

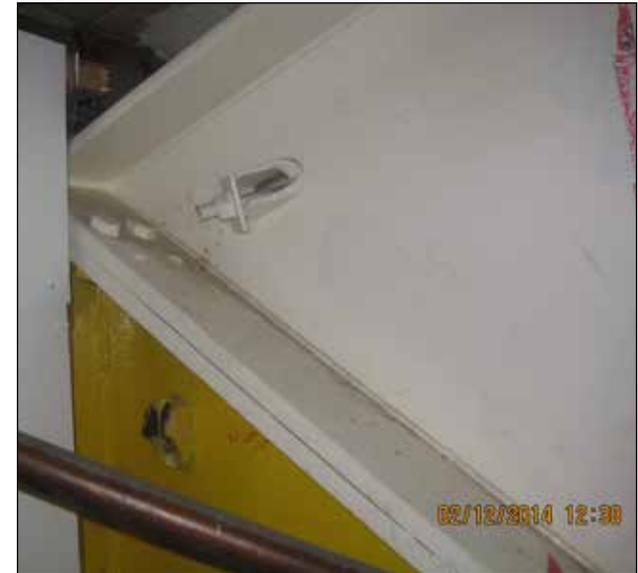
4. Possible removal of wall-level cross bracing.

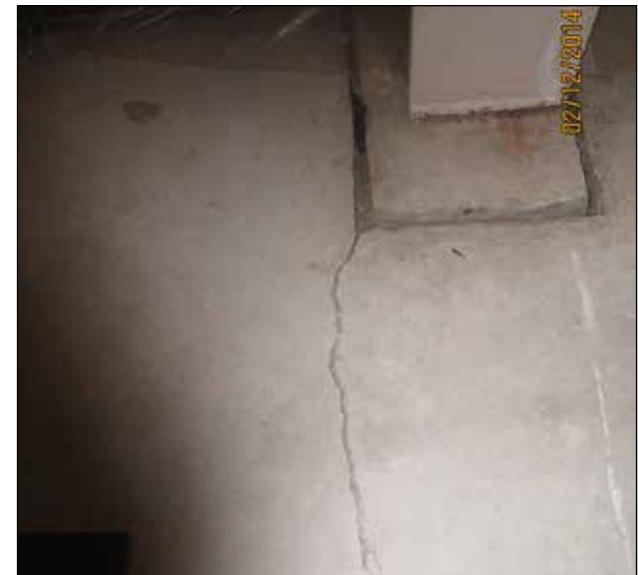
5. Floor slab cracking at column locations.

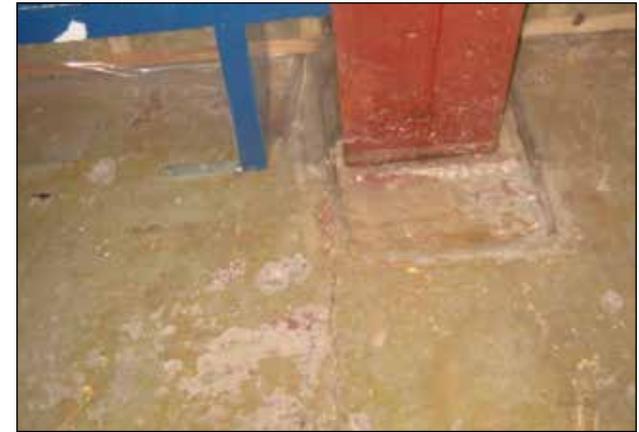
6. Floor slab cracking at column locations.

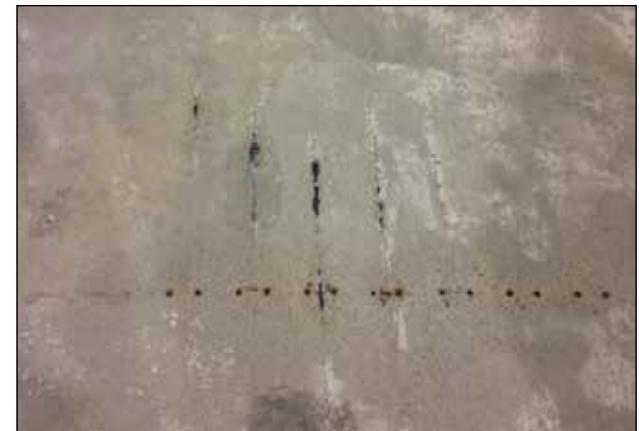
7. Corrosion of steel within the floor slab.

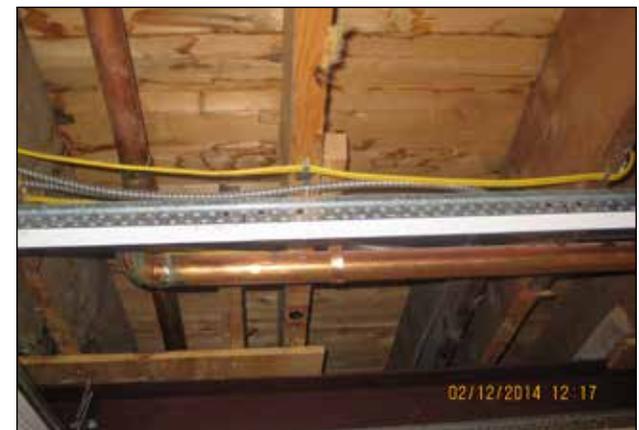
8. South mezzanine floor framing.

Much of the structure is balloon-framed with only nails supporting joists where they are attached to studs. This wood framed structure also exhibits signs of water damage and potential rot.

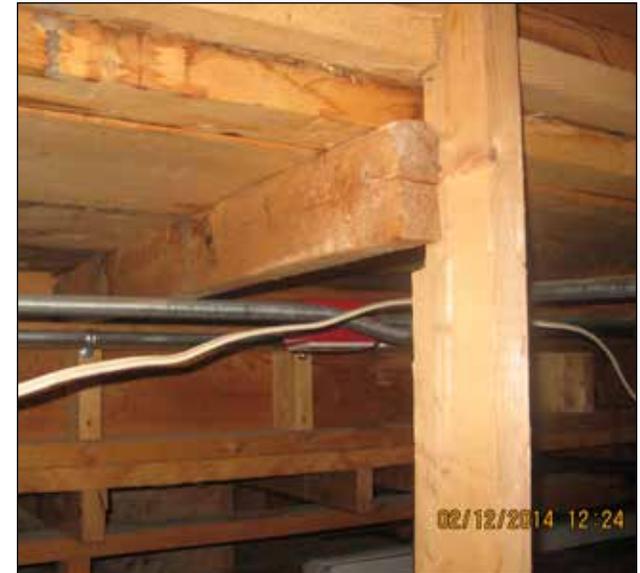
- The wood frame bleaches on the east side of the stadium are severely under-designed for expected live loads and totally unacceptable as per the requirements of the National Building Code. Many framing members are undersized with 38 x 89 mm studs used as floor joists throughout. The vast majority of the wood-to-wood connections and the wood-to-steel connections are unacceptable (images 9-11).

9. East bleacher wood framing.

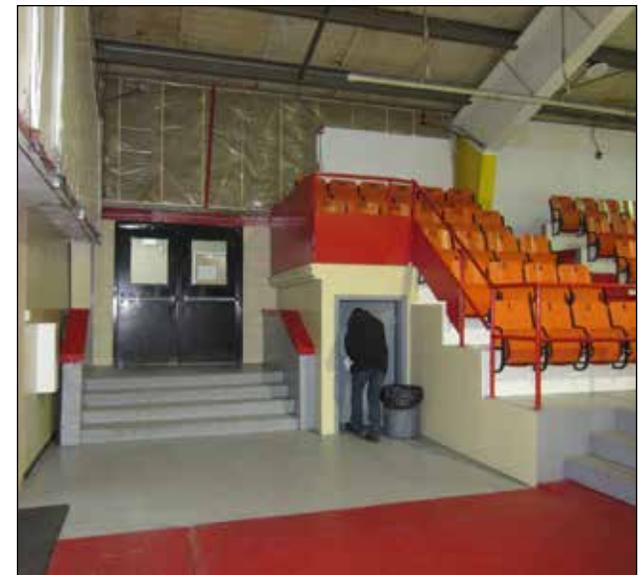
The amount of exposed vapour barrier on the exterior walls beneath the bleachers is a concern. Polyethylene film typically has a flame spread rating of less than 150, so exposed use is not strictly prohibited by the National Building Code, however it is not advisable and the situation should be discussed further with the authority having jurisdiction.

Exposed vapour barrier and plywood wall finishes.

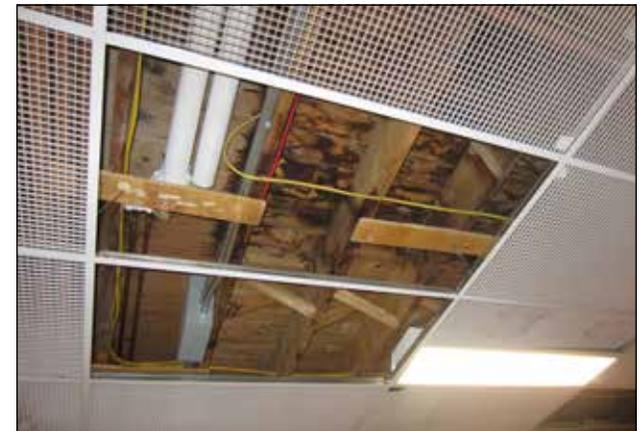
Ceiling finish and water damage under south mezzanine.

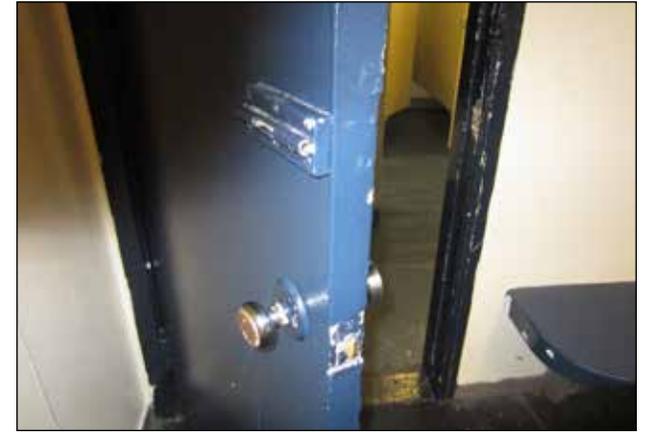
Improper hardware on change room door in egress path.

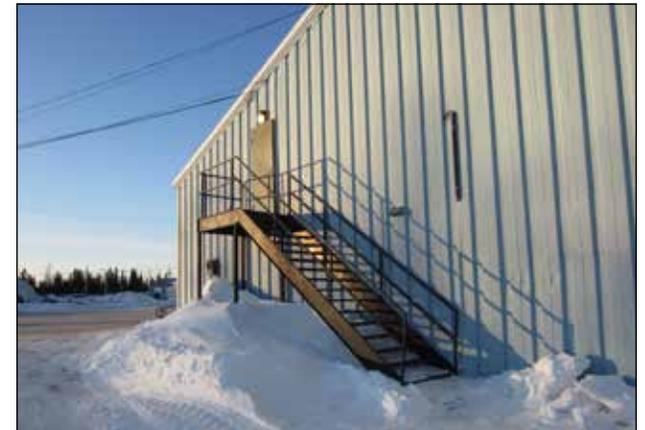
One of two exterior fire escapes from south mezzanine.

Exiting from the original southern mezzanine does not comply with the NBCC and is cause for concern. The mezzanine does have two exterior fire escapes in addition to the central stair into the arena. However, the access to these means of egress is actually through the change rooms and washroom at either side of the building. Exiting through adjacent rooms, like the change room and washroom, as opposed to exiting directly from the corridor, is in contravention of current day codes. The fact that the change room and the washroom doors may be dead-bolted is a serious life safety is-

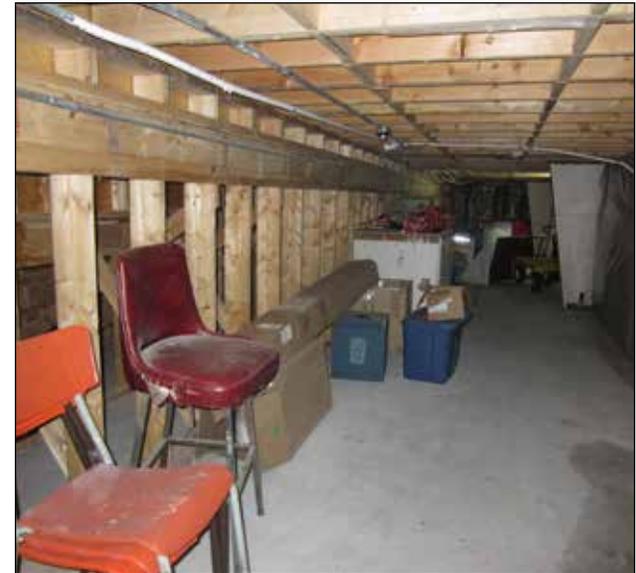
Passageway under west bleachers, exposed wood framing.

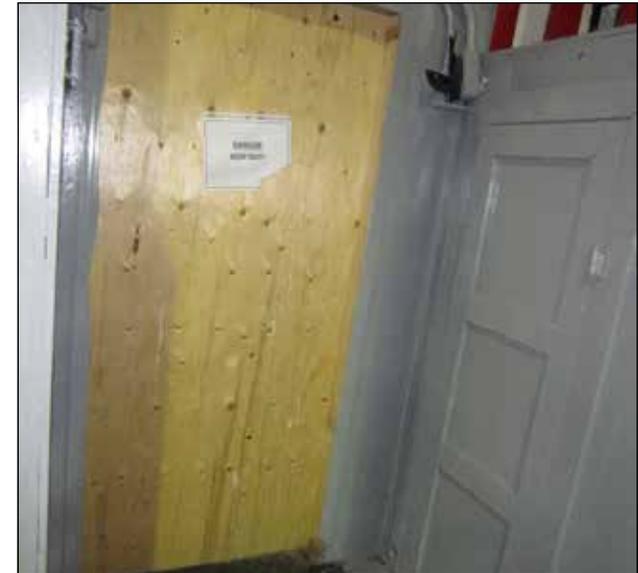
Barricaded former access to exit from the east bleacher.

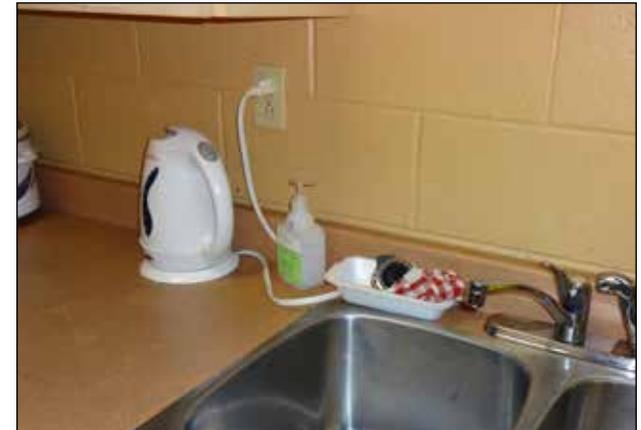
Receptacle by sink in 2005 extension without GFI.

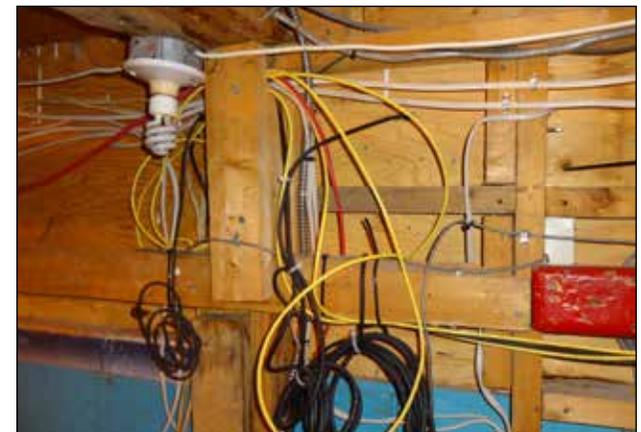
Improperly supported wiring under bleachers.

It is imperative that R60 and TW rated conductors be replaced with RW90 rated conductors. The existing wiring has deteriorated and presents a high risk of shorting or arcing. In addition, all junction boxes require covers and all cable and conduit needs to be properly anchored or otherwise supported. Power conductors should also be colour coded.

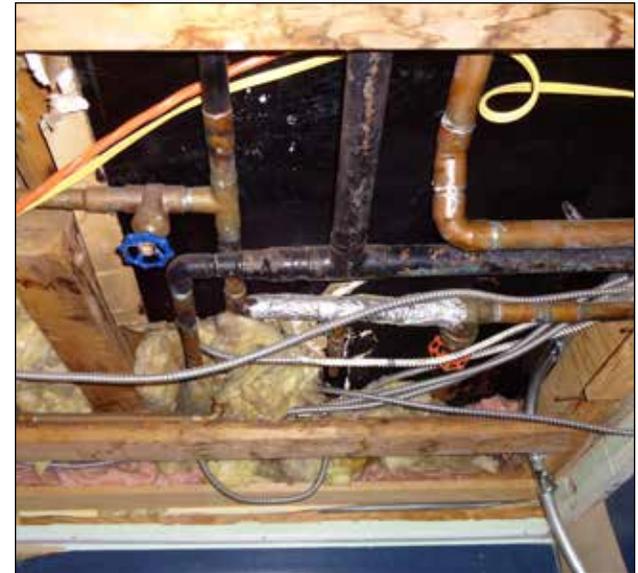
Improperly run and supported wiring in south mezzanine.

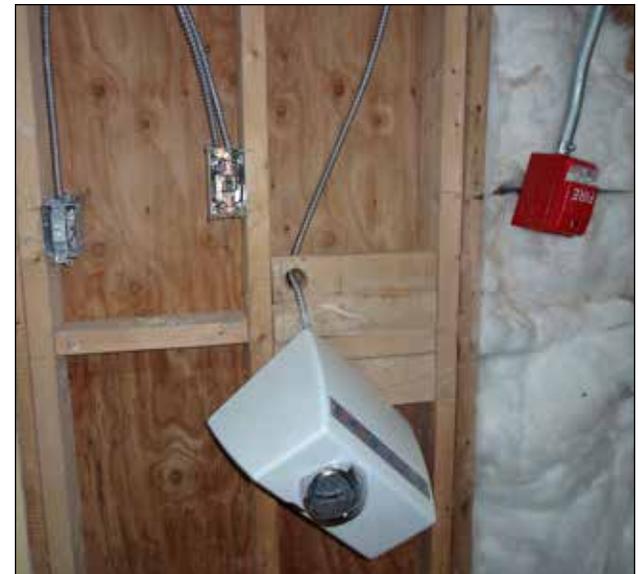
Open device boxes and unsupported electrical devices.

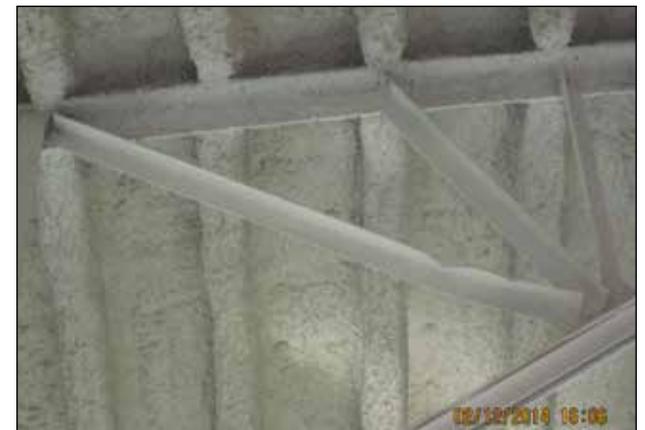
3. Evidence of web-member buckling on a typical truss.

It is impossible to be absolutely certain, but considering the notation on the 1973 drawing and the fact that further repairs were necessary in 1980, it is likely that the buckled truss members visible today predate the 1980 reinforcement. It was probably deemed unnecessary to remove and replace them at that time.

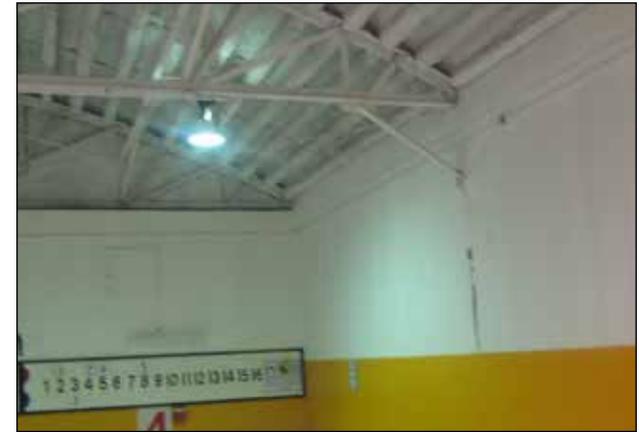
6. Typical wall finish cracking at columns.

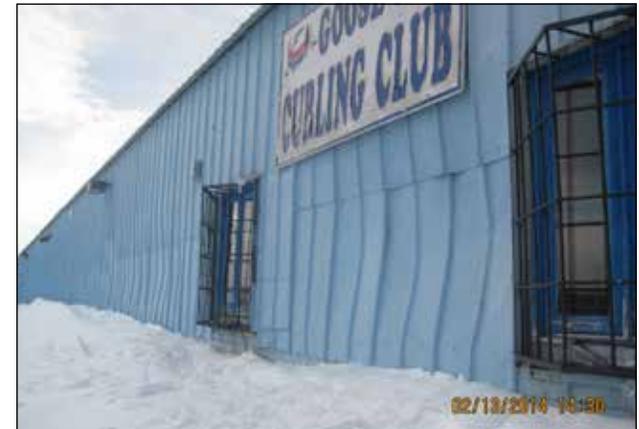
7. Damage to exterior cladding and wall support structure.

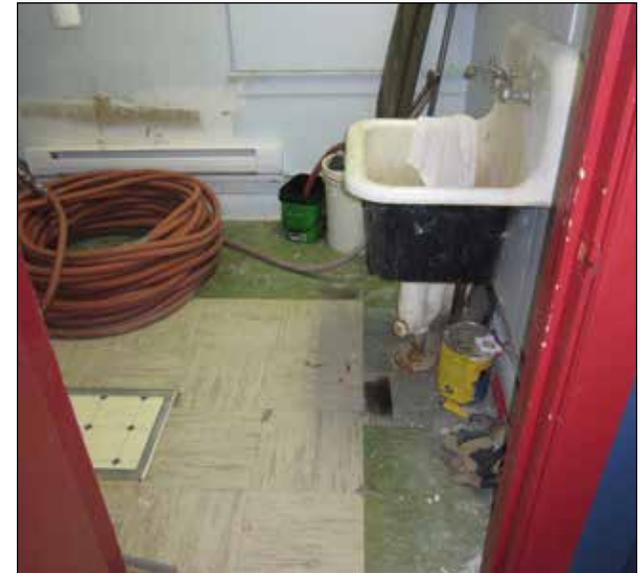
Asbestos-containing floor tiles in janitor's room.

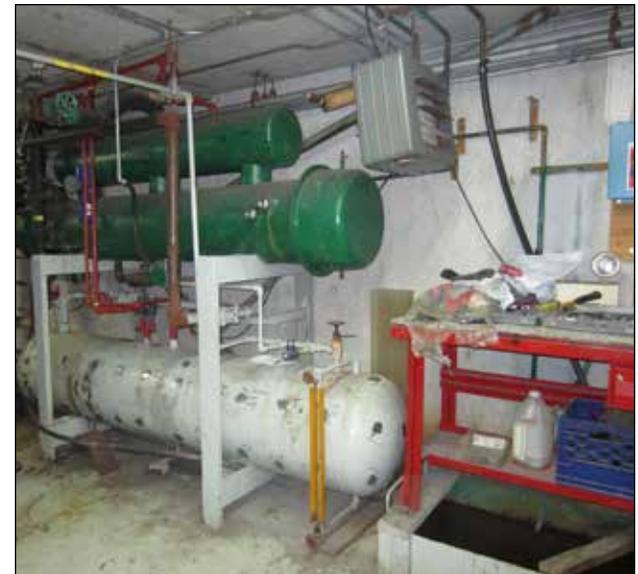
- The ice plant is approximately 57 years old and in very poor condition. The ammonia expansion tanks are structurally deficient and were condemned by Service NL inspectors during the compilation of this report. Currently the facility cannot operate until the tanks are replaced.

Ammonia tank with evidence of structural testing.

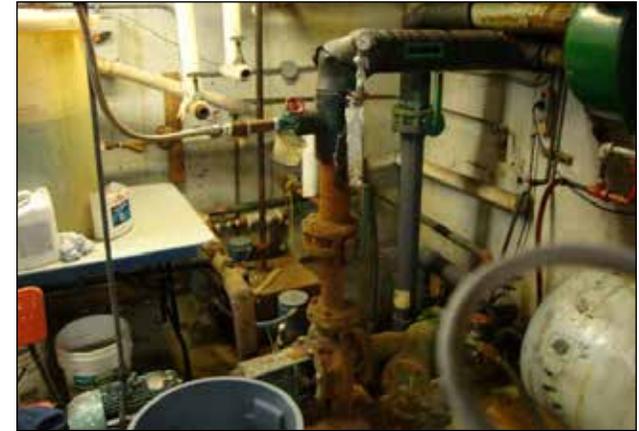
Severely corroded piping, likely associated with CAF Arena.

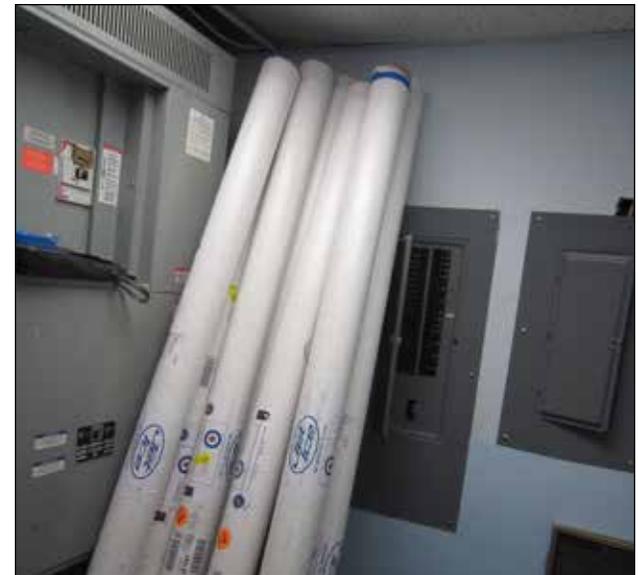
Items stored in main electrical room.

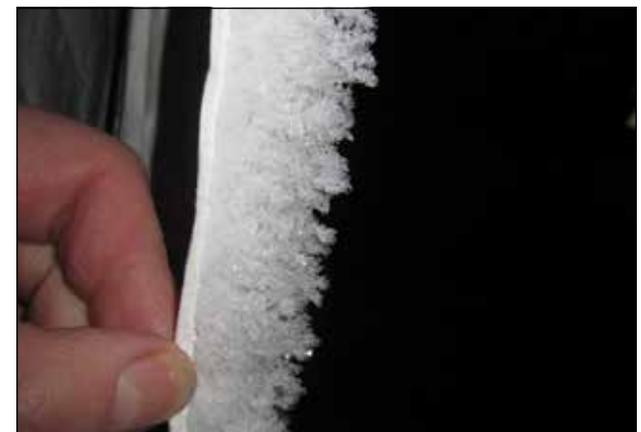
Frost on pool side of divider curtain.

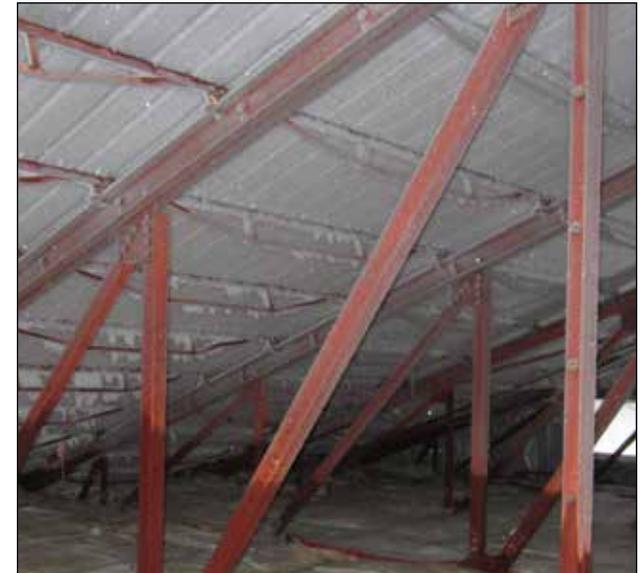
- There are serious issues with humidity and air vapour transmission from the pool area into the unheated attic area. Despite numerous attempts to resolve this issue in the past, there is so much warm moist air escaping into the attic that during the February review there was 25 mm of ice covering the roof structure above the pool. When this ice melts, the water will saturate the aquatics area's upper ceiling.

Ice build-up on the metal roof deck and structure over pool.

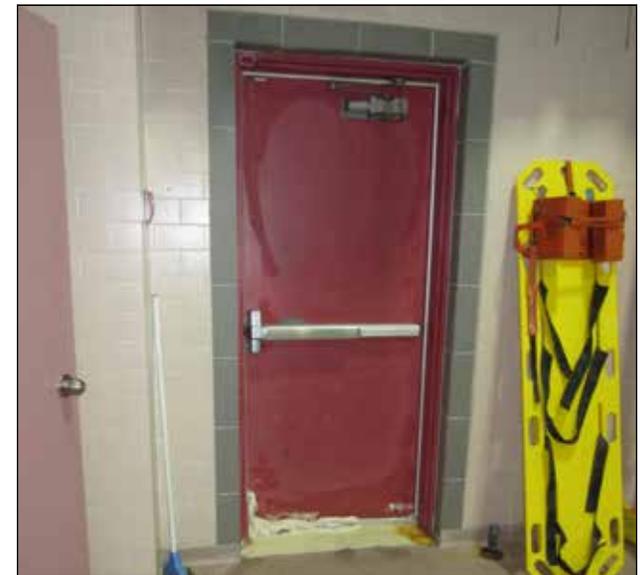
Pool area exterior door with frost and ice build-up.

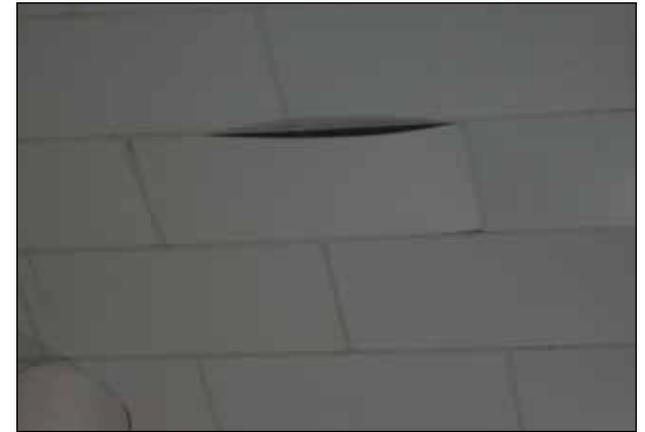
Moisture-soaked ceiling tile falling from ceiling over pool.

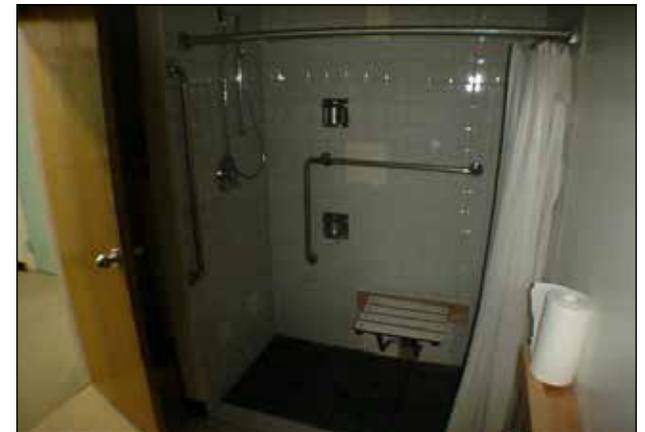
Shower in supposed barrier-free washroom.

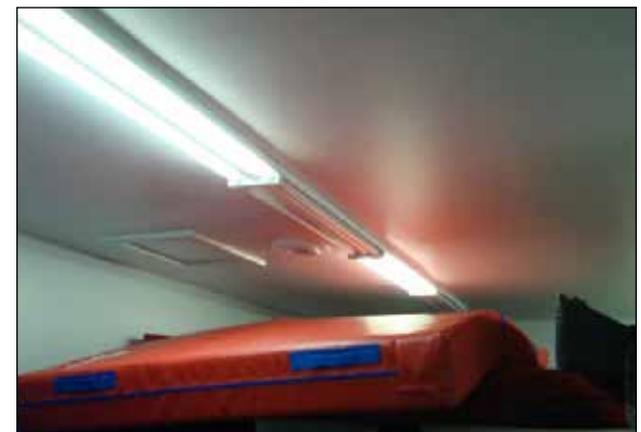
Storage room lighting missing lenses and lamps.

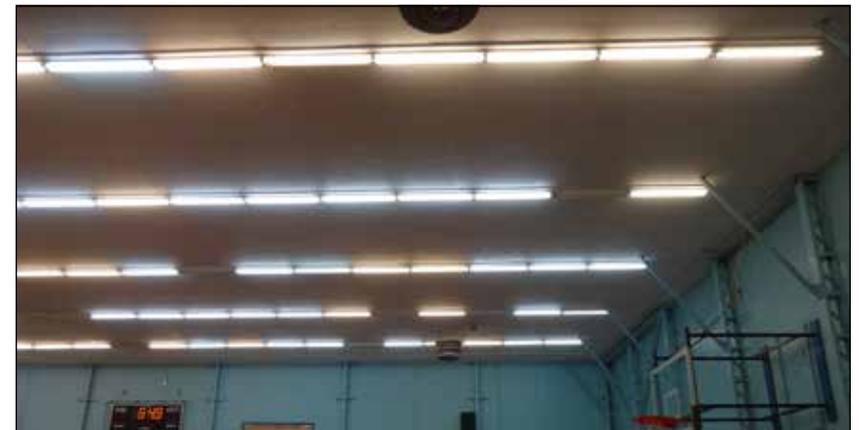
Lighting in the gym with mismatched colour temperatures and burned out units.
