**FACILITIES AUDIT, REDEVELOPMENT SCENARIOS AND FINANCIAL ANALYSIS
FOR MUNICIPAL WELLNESS INFRASTRUCTURE PROJECTS
IN THE TOWN OF HAPPY VALLEY-GOOSE BAY**

SHEPPARD CASE
ARCHITECTS INC

June 2, 2014

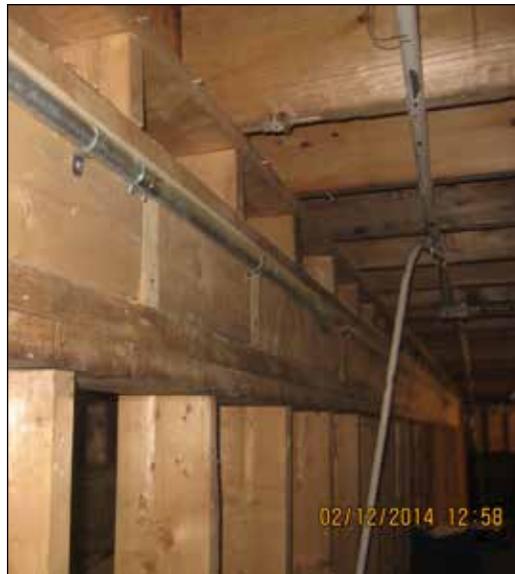
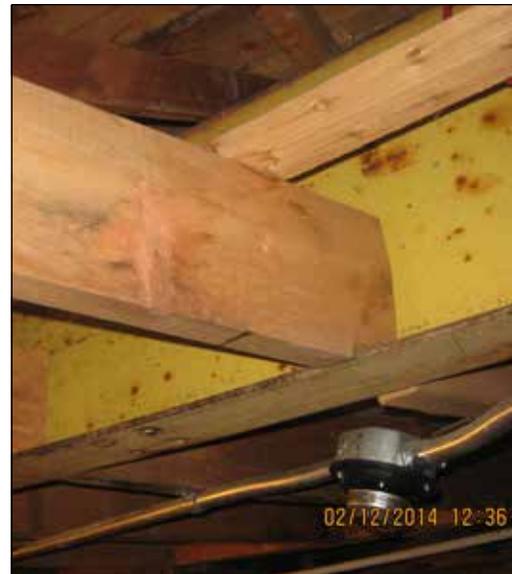
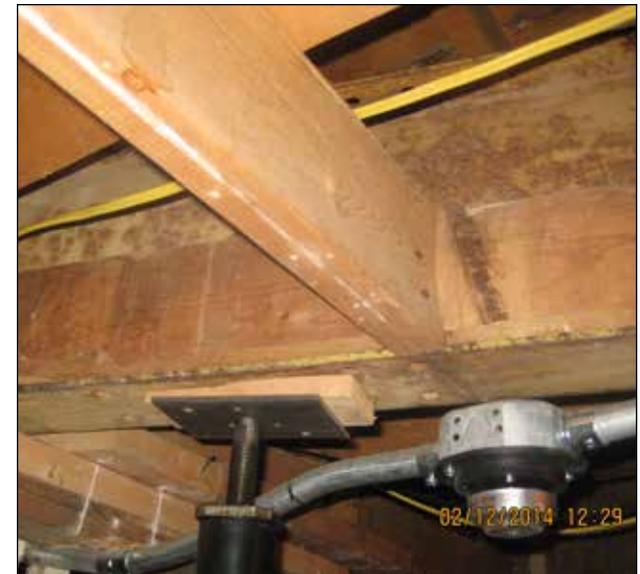
same can be said for the wood frame additions, however it does not appear as though the east bleacher would have satisfied the requirements of any NBCC since the 1970s. The steel erection drawings for the 2005 extension were available and the design appears to be in conformance with the 1995 edition of the NBCC.

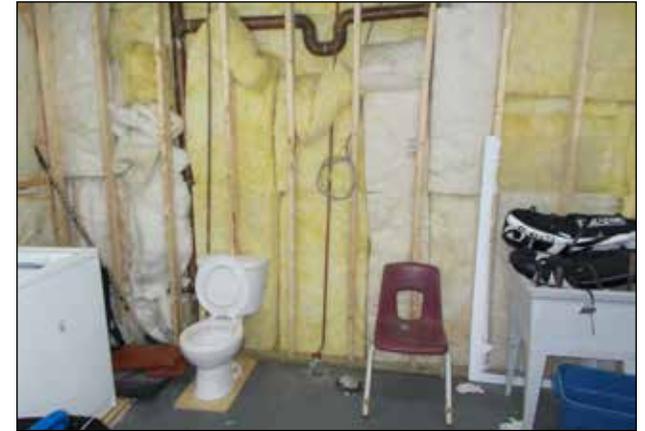
No vapour barrier or wall finish on exterior wall.

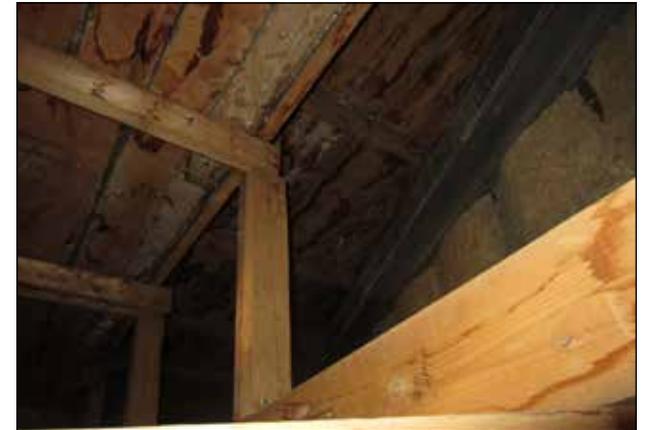
No continuity of insulation at bleachers, no vapour barrier.

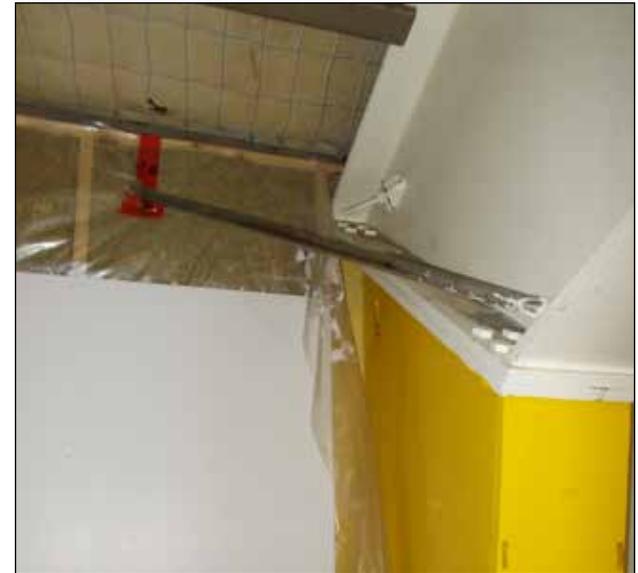
Throughout most of the building the continuity of insulation and vapour barrier is very poor and exposed areas of insulation have been left unfinished without any vapour barrier for extended periods of time. There are also wall areas in unfinished spaces (such as under the east bleachers) that have little to no insulation. The back of the cladding panels are visible in these areas. In addition, vapour barrier continuity has not been achieved across the primary steel arches or at the interface between the wall and roof assemblies.

Discontinuity of vapour barrier and insulation at structure.

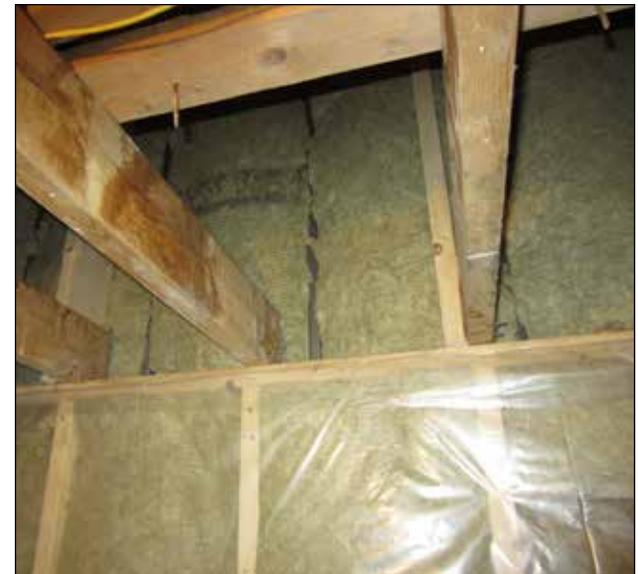
The amount of exposed vapour barrier on the exterior walls beneath the bleachers is a concern. Polyethylene film typically has a flame spread rating of less than 150, so exposed use is not strictly prohibited by the National Building Code, however it is not advisable and the situation should be discussed further with the authority having jurisdiction.

No vapor barrier and poor insulation coverage at bleachers.

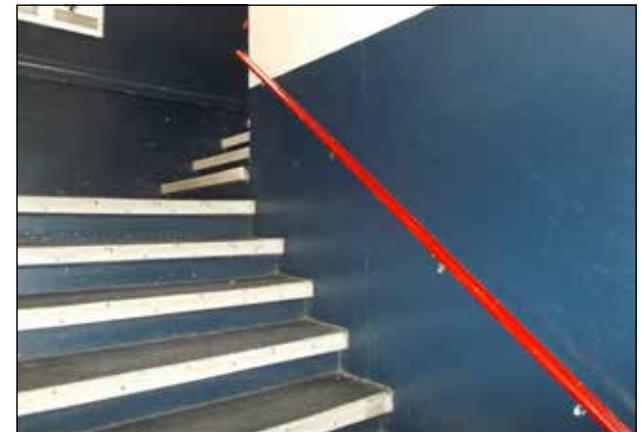
The stairs to the southern mezzanine are covered with a black skate-resistant rubber with white high-density polyethylene (HDPE) nosing strips. This surface, while highly durable, can be very slippery when wet. Dimensionally (riser height and depth), these stairs do not conform to current National Building Code of Canada (NBCC) standards. The residential-quality wooden handrails are also non-conforming, in that they are discontinuous and do not extend for the required distances beyond risers.

South mezzanine stairs c/w rubber treads and HDPE nosing.

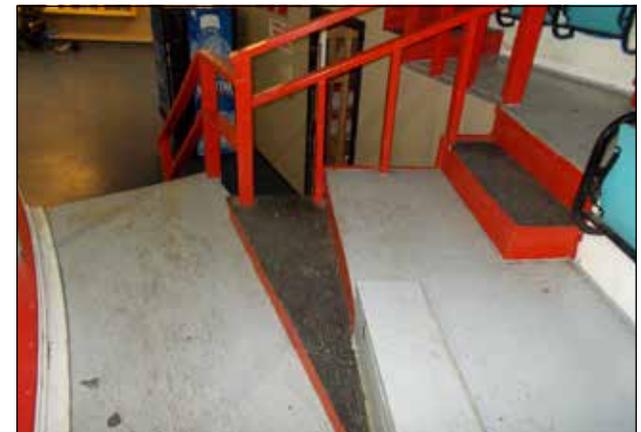
Typical nonconforming stair and guard at east bleachers.

There are several sets of stairs forming an integral part of the wooden bleachers. These stairs vary in dimensions and finish: some have a ribbed rubber covering and nosings, while some are simply painted wood without nosings. Dimensionally, none of these stairs would meet the current requirements of the NBCC. Handrails and guards have been fabricated from dimensional lumber and also do not conform with NBCC or provincial accessibility requirements in terms of their height, the size of openings or their ability to resist lateral loads.

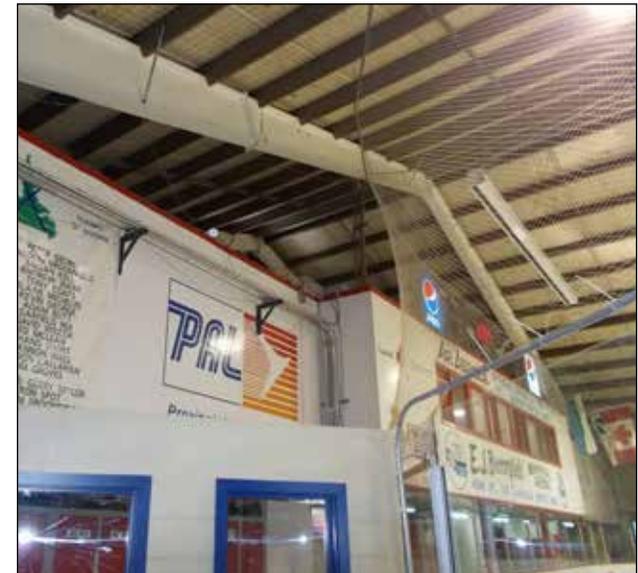
All other partitions throughout the original structure, including those supporting the bleachers and enclosing spaces beneath, are framed with wood studs. A surprising amount of this framing is completely exposed, without cladding, leading to concerns with respect to the degree of combustible construction and flame spread issues. Where partitions are finished, it appears to be with plywood or fibre board (hardboard). This is particularly true in the corridors and stairwells, where the flame spread rating on the walls is not permitted by the NBCC to exceed 75 and 25 respectively. Plywood has a flame spread rating of 110 and fibre board has a flame spread rating of 150, which both greatly exceed Code requirements.

South mezzanine partition with main arena open area.

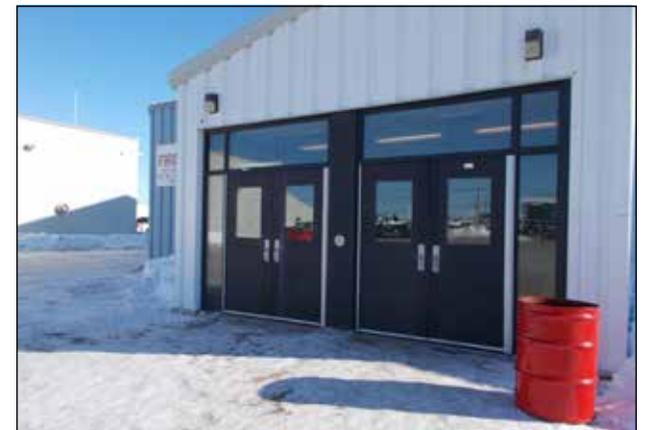
At the time of the site review, the power operators provided for the entry doors were not operational either because they were disengaged or malfunctioning. This should not be permitted in a public building like the arena.

New accessible main entrance system, 2005 extension.

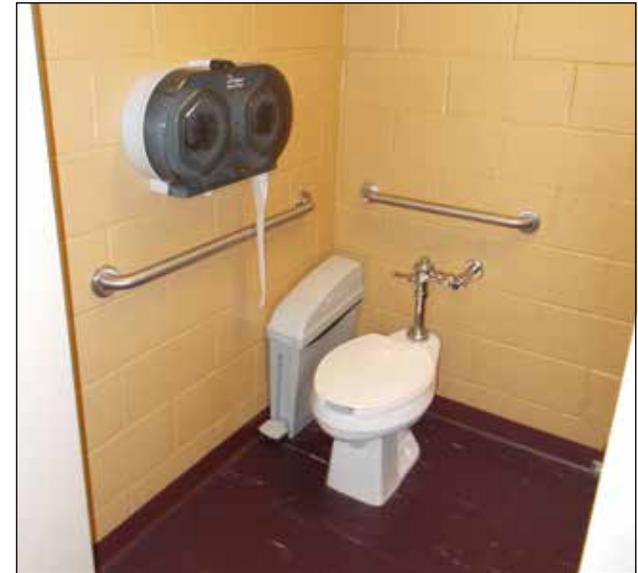
Typical barrier-free toilet stall. Tissue dispenser is too high.

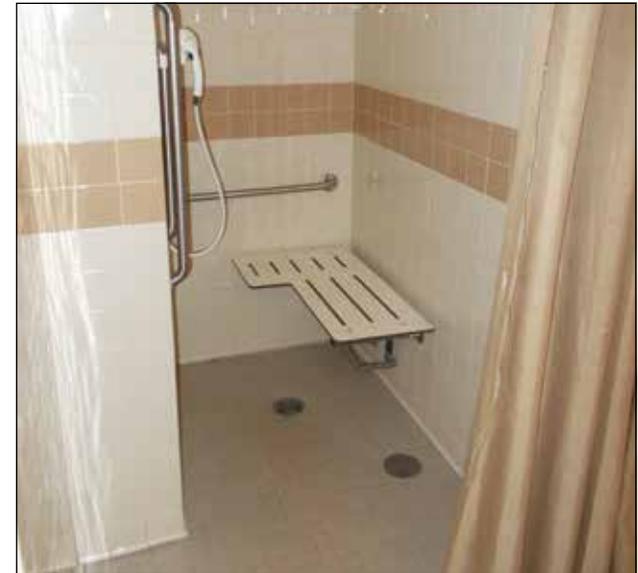
Nonconforming barrier-free shower in south change rooms.

Surprisingly, there are aspects of the 2005 accessibility renovations which are non-compliant. The seat in the shower, for example, is on the wrong wall as the barrier free zone outside the shower is supposed to extend 300 mm beyond the back of the seat. This renders the entire plumbing and grab bar arrangement incorrect as well. It is important to note that the as-built arrangement is contrary to the design drawings which configure the shower correctly.

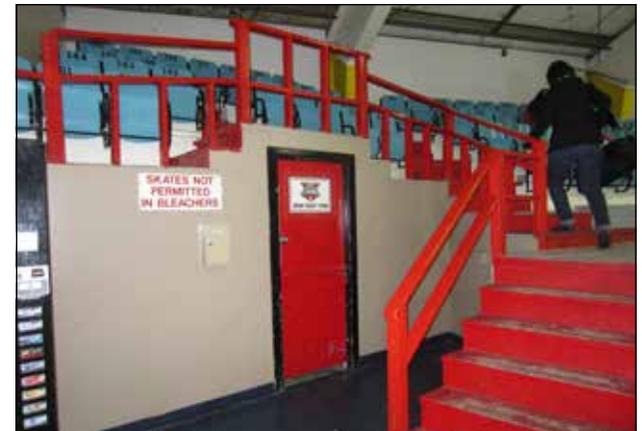
Typical nonconforming stairs and guards at bleachers.

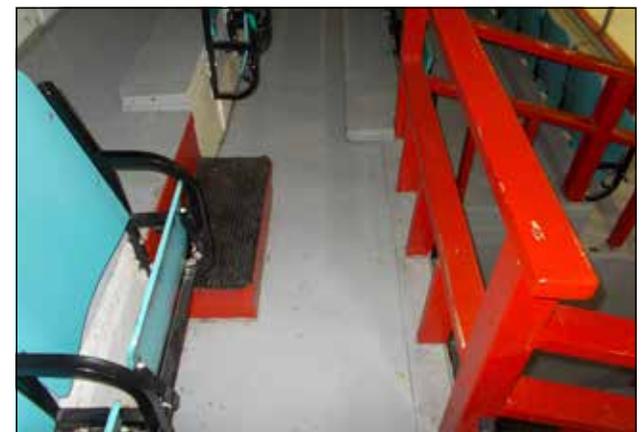
Typical obstruction in bleacher aisle, nonconforming guard.

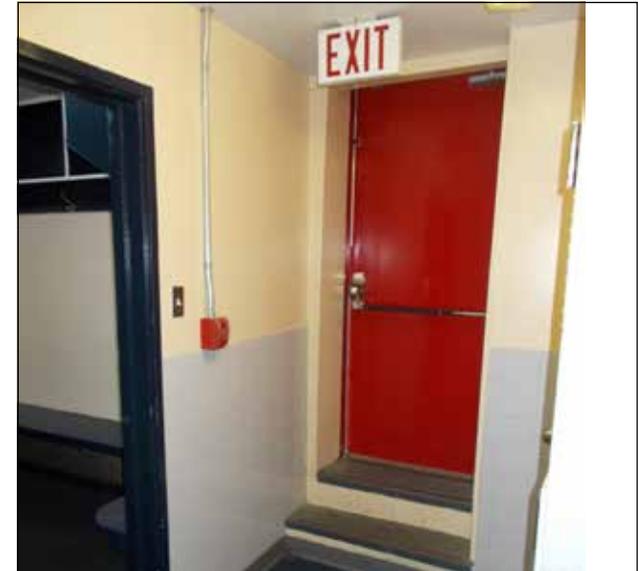
South mezzanine exit door to exterior fire escape.

sue which should be rectified immediately. It may be argued that the doors would not be bolted when the rooms are in use, but this does not reduce the hazard as it cannot be properly controlled by staff or other occupants. In addition, the NBCC stipulates that a change in elevation in an assembly occupancy has to be addressed with a minimum of three risers to avoid a tripping hazard. The exit doors from the south mezzanine feature only two risers.

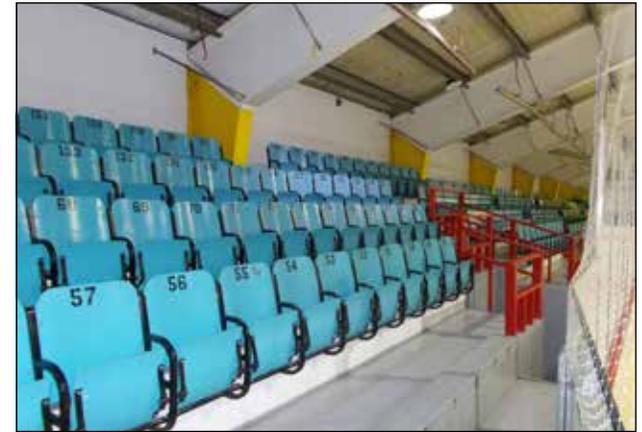
There are a great many issues with the bleacher seating. All of the bleachers in the Broomfield Arena are wood frame construction. As has been previously discussed, under most occupancy scenarios, combustible construction would not be permitted in this building. In the very least, the combustible construction of the bleachers should be protected from adjacent spaces underneath with a fire rated partition or cladding system.

View of the (older) east bleachers.

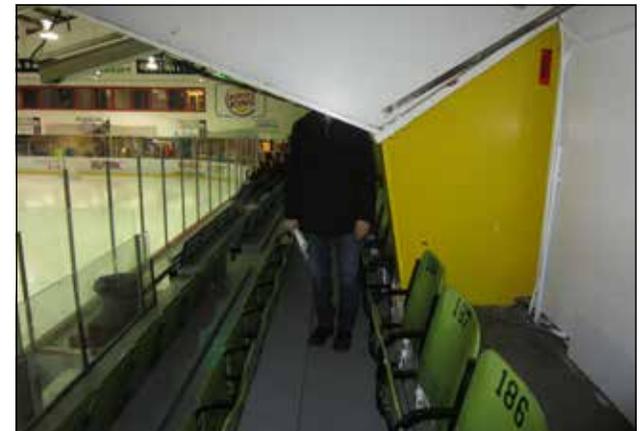
Typical obstruction of the cross aisle by the rigid frame.

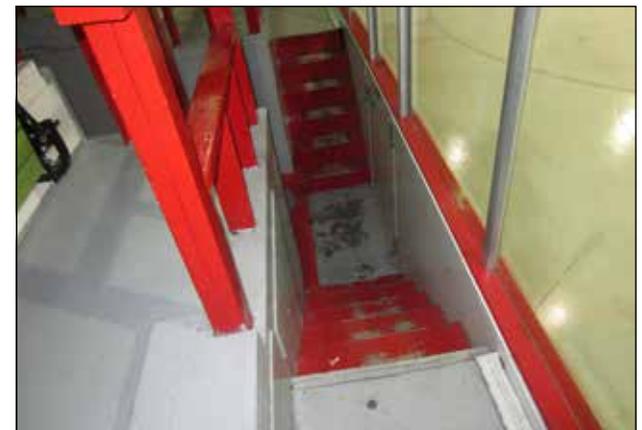
The only means of egress from the east bleacher is at the far ends of the entire structure. It appears as though there was once passages through the seating area to the area under the bleacher, where people would then have access to exits at floor level, but these openings have been boarded up. However even if they were opened, the underside of a combustible bleacher would not satisfy the construction requirements of an access to exit and there is insufficient headroom clearance. The existing situation whereby all of the spectators on the east bleacher (in excess of 300 people) are

Stairs/cross aisle and access to exit from east bleacher.

funneled into and through a number of 620 mm wide stair passages on their way to a single exit is extremely dangerous.

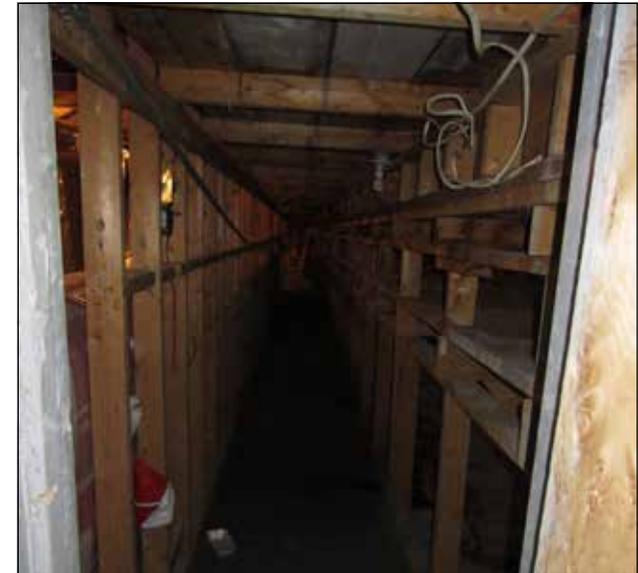
Passage under east bleacher, exposed wood framing.

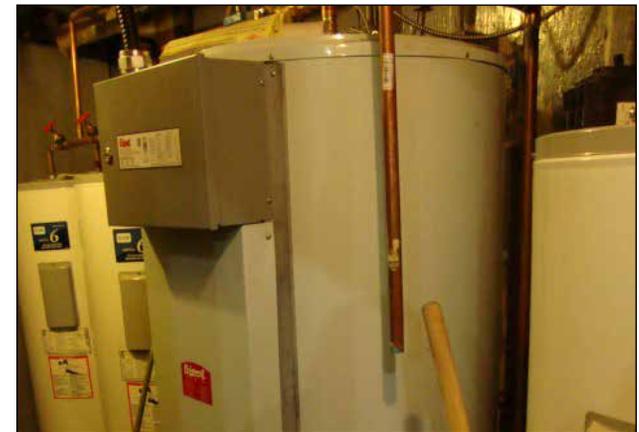
Domestic hot water heaters with uninsulated pipes.

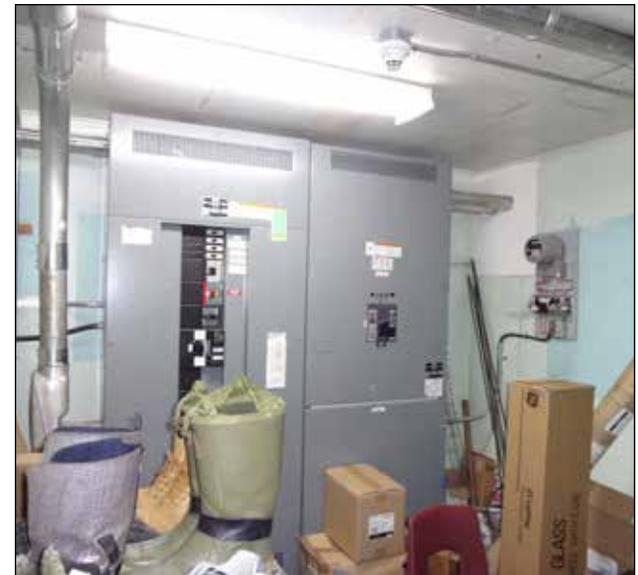
- The main service entrance board is in fair condition.
- The main electrical room is used as a storage room which is contrary to Code and limits working space in front of electrical equipment.

Main electrical room being used for storage.

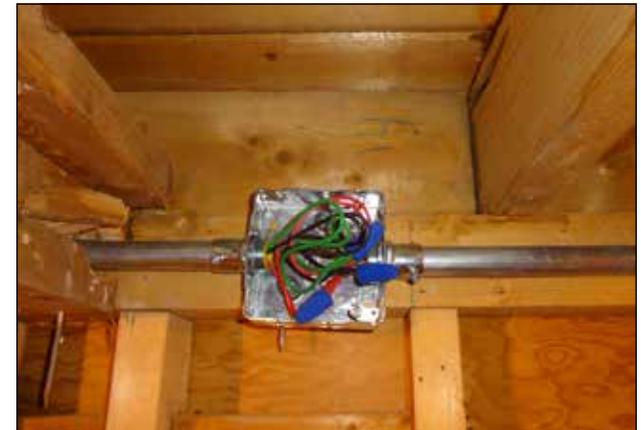
Uncovered junction box under bleachers.

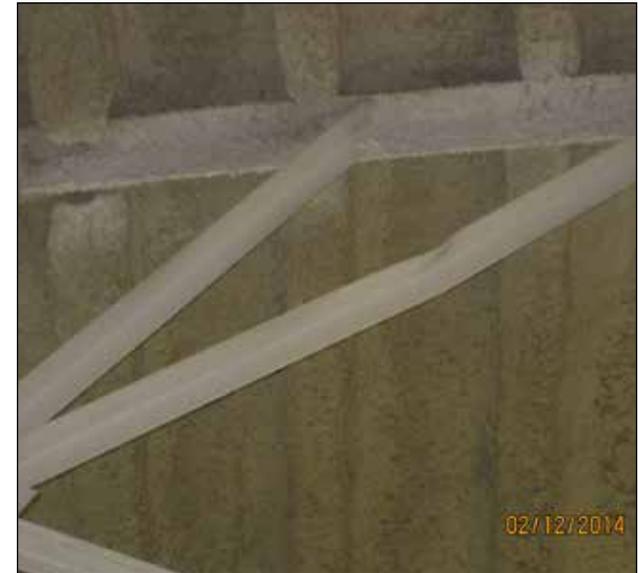
4. Evidence of web-member buckling on a typical truss.

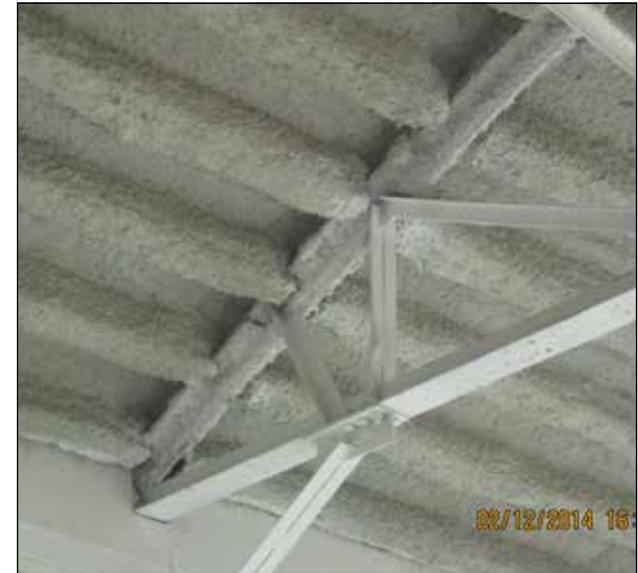
5. Web-member buckling on a typical truss near column.

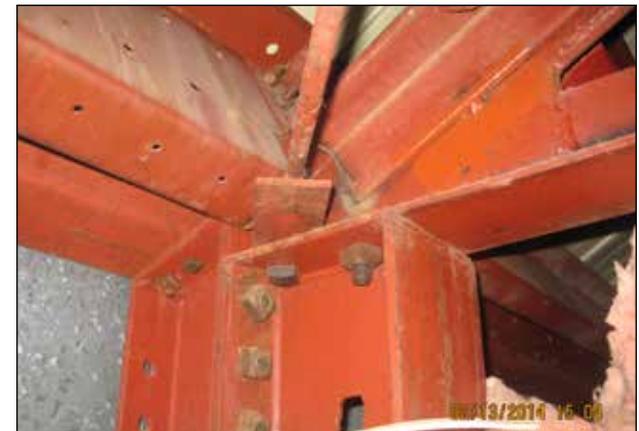
- The connection between the perimeter columns and the trusses appear to be full moment connections (image 8) which could result in increased deflection in the column, especially if the column is under-designed.

8. Typical 1980 moment connection at column and truss.

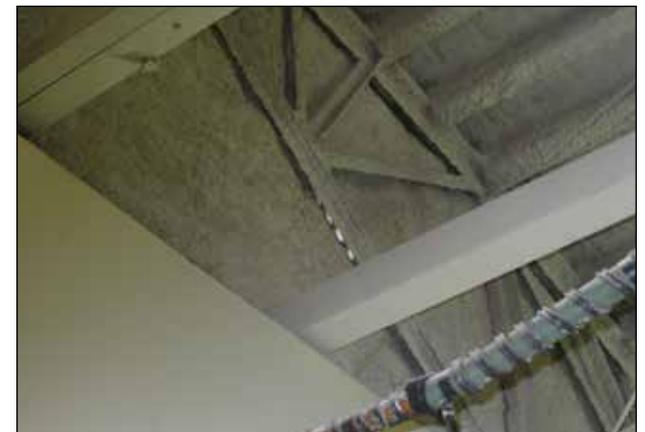
West end wall. Note daylight visible through wall finish.

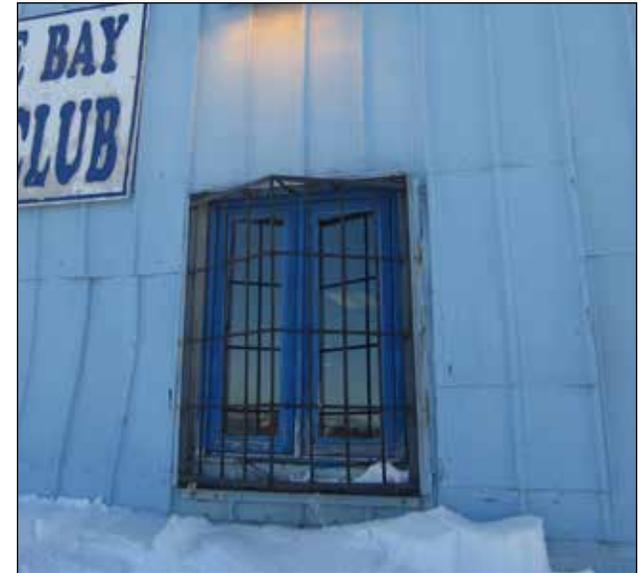
Wood window installed in 1983 with steel security grille.

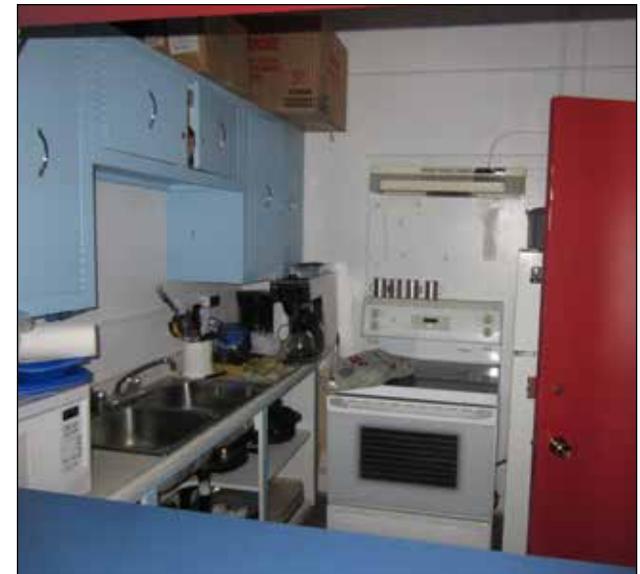
Canteen cupboards and residential equipment.

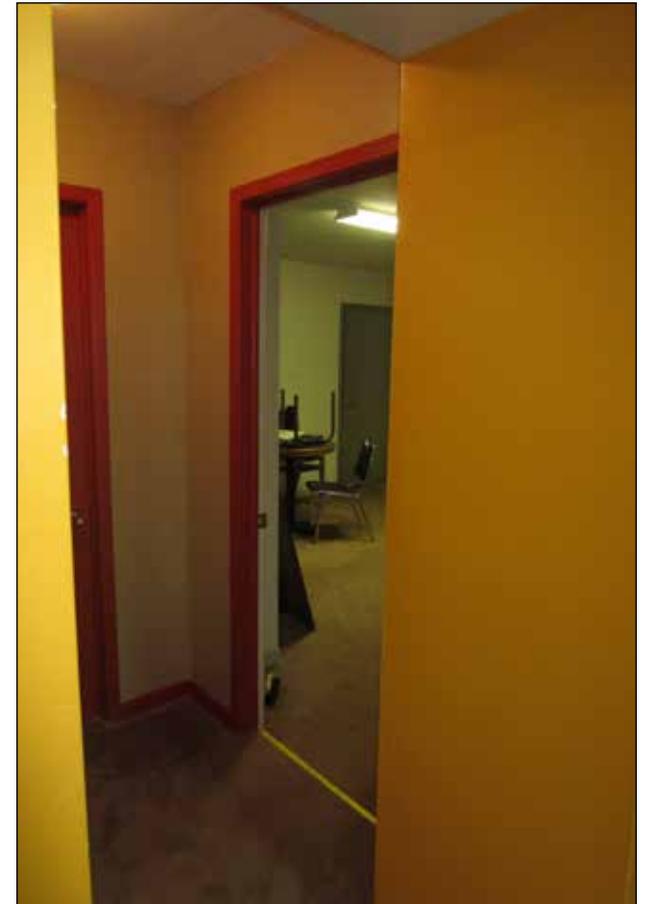
View from lounge to exit door through east locker room.

The secondary means of egress from the lounge is through the east locker room then a vestibule which also leads to the mechanical room. There are numerous violations associated with this route:

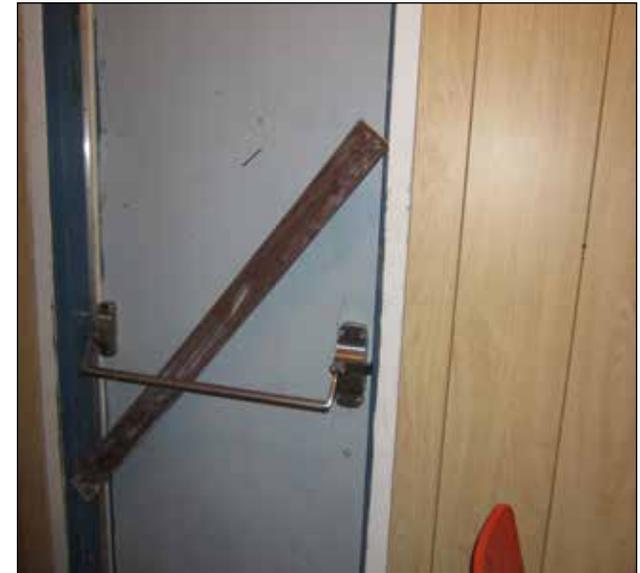
Exterior fire-exit door barred shut with wood plank.

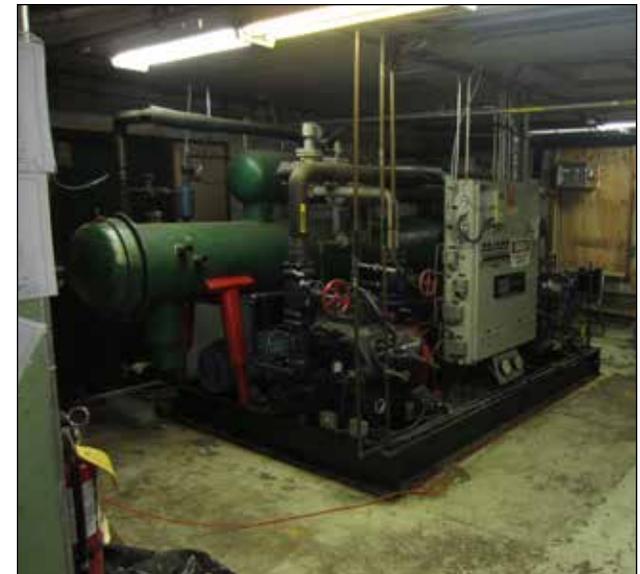
Ice plant machinery in mechanical room.

The refrigeration plant, the brine piping system and the control system are all in very poor condition and cannot be expected to last much longer without causing major problems. In fact, in February of 2014 Service NL's Boiler and Pressure Vessel Division issued directives to the Goose Bay Curling Club to replace several pressure vessels in the plant due to corrosion and structural degradation.

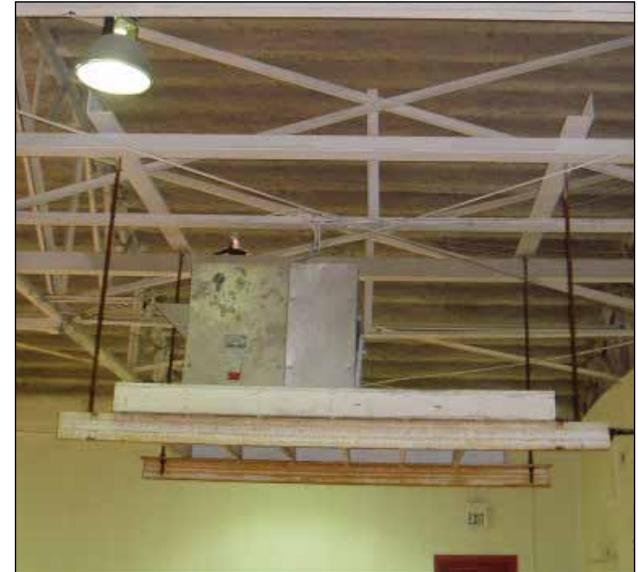
There is a single dehumidifier mounted on a ceiling-suspended platform at one end of the ice surface. It was difficult to determine if this unit was functioning correctly.

Dehumidifier unit in rink area.

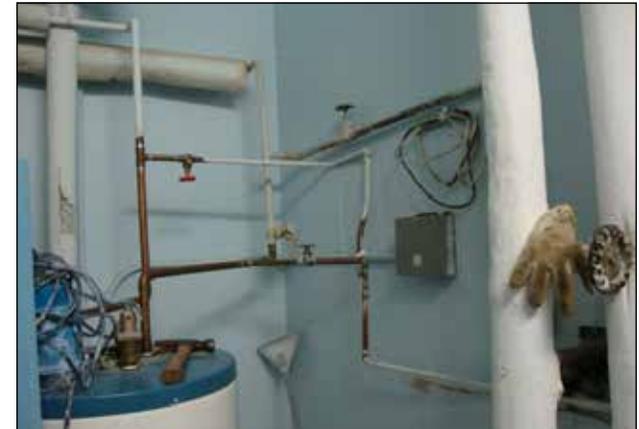
With the exception of washroom fixtures, most all components of the plumbing system are old and in poor condition. Leaks would be likely occurring for a system of this age, which has reached the end of its service life.

Hot water heater and associated piping.

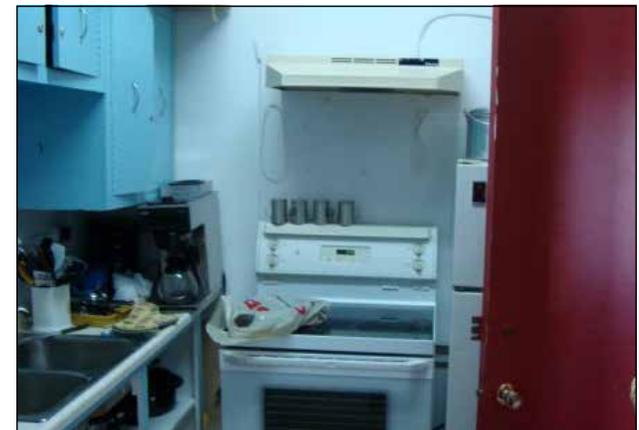
In the canteen area there is only a residential re-circulating range hood above a typical residential-quality range/oven combination. The Fire Commissioner's office would likely require that a NFPA approved stainless steel exhaust hood with integral fire suppression be installed for continued operation of the canteen.

Un-vented residential hood in canteen area.

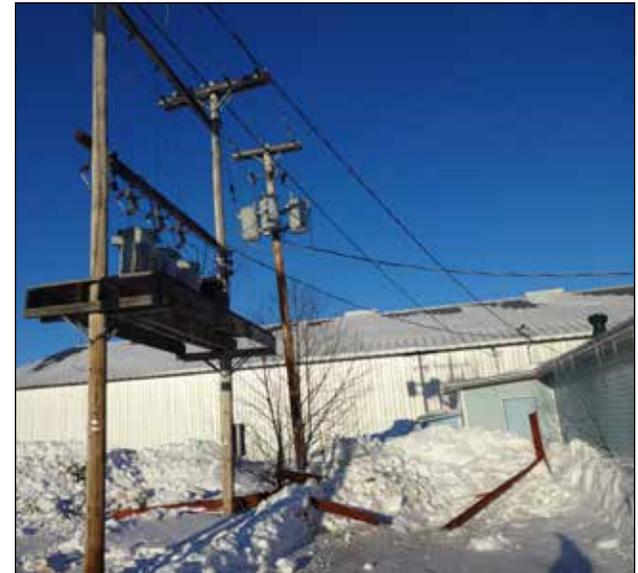
The main electrical room is being used for storage, which is contrary to Code and fire safety regulations. The main service entrance is rated 400 amps, 120/208 volt, 3 phase, 4 wire and is comprised of a single section service entrance board complete with a 400 amp, three pole main circuit breaker. The service entrance board is manufactured by *Federal Pioneer*, appears to be fairly new and is in good condition. The board feeds multiple older distribution panels and mechanical equipment located throughout the facility. The older distribution equipment is manufactured by *Square D*. The maximum peak demand of each of the utility meters is: number P71213 – 82.0 kilowatts; number P71025 – no demand; number P34524 – 43.2 kilowatts.

Transformers and service entrances.

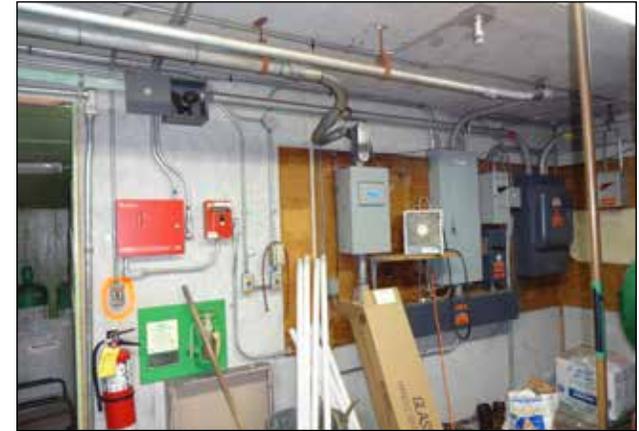
- The 120/208 volt distribution is in poor condition. The trip accuracy of the original breakers is questionable.
- General wiring types include RW90, Teck, AC90, NMD, R60, and TW wiring used as conductors.

Service entrance and distribution in mechanical room.

If a major renovation of the curling club is considered, most all of the secondary 120/208 volt distribution equipment original to the building would have to be replaced in order to rectify the issues noted above.

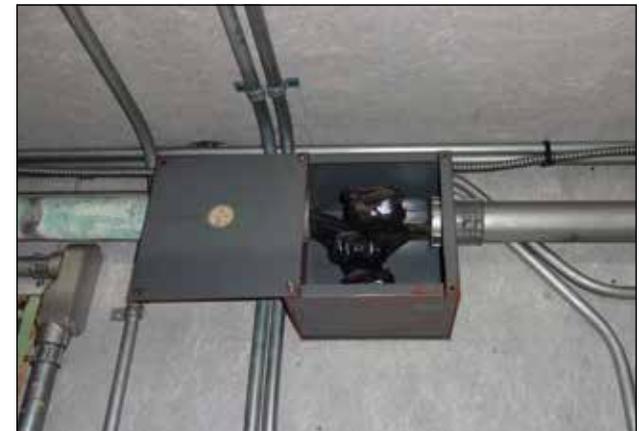
There is a variety of wiring methods employed in the building. There is RW90 in conduit, TECK, AC90, NMD, R60 in conduit and TW wiring used as conductors in conduit. Generally, the wiring is in poor condition.

Open junction box with exposed conductors.

It is imperative that R60 and TW rated conductors be replaced with RW90 rated conductors. The existing wiring has deteriorated and presents a high risk of shorting or arcing. In addition, all junction boxes require covers and all cable and conduit needs to be properly anchored or otherwise supported. Power conductors should also be colour coded.

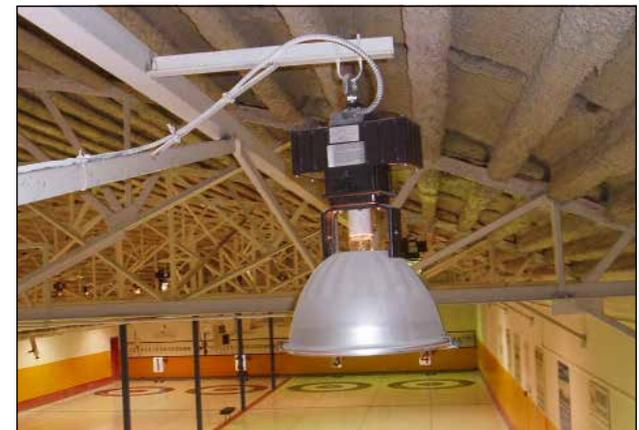
There are two main types of interior lighting in the facility: high-bay metal halide over the ice surface and T12 fluorescent lighting in the remainder of the building. The high-bay metal halide lighting appears to be in fair condition. All lights are in working order with a good lighting distribution and very little shadow cast onto the ice surface. The fluorescent lighting is comprised of 305 x 1,220 mm surface mounted fixtures, 610 x 1,220 mm recessed fixtures or strip lighting fixtures within the mechanical and other service rooms. There are also some incandescent pot-lights.

Typical metal halide high-bay light in ice rink area.

The interior lighting systems remain serviceable, though if a major refit of electrical systems is considered, it would be advisable to replace the incandescent pot lights and the older T12 fixtures with new, energy efficient compact fluorescent and T8 fixtures.

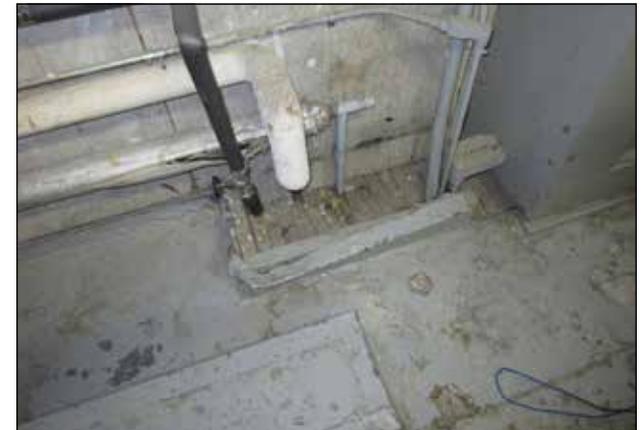
- There is no visible sign of deterioration or failure in any of the existing steel components that were accessible to view.
- The floor of the mezzanine HVAC room appeared to have a concrete topping installed on top of wood decking. The concrete topping is generally in poor condition and the floor system as a whole should be examined in more detail.
- In the stair down to the pool mechanical room there are some exposed steel beams that are supporting the floor above. A fair amount of moisture had condensed on the steel which will eventually cause corrosion, though the amount present at this time does not pose an immediate hazard.

HVAC room floor, concrete topping over wood mill floor.

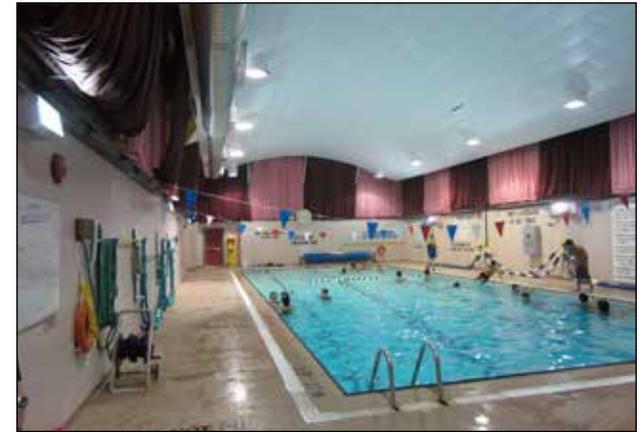
There are major problems with vapour penetration of the ceiling assembly over the pool area. In an attempt to remedy the issue of vapour penetration and consequent condensation within the attic space, a number of *band-aid* solutions have been applied. From the exterior, the excessive amount of ventilators (approximately 20 on the roof-top and 10 in the gable ends) is immediately noticeable. These were most likely added to increase air flow in the attic in an attempt to lower the humidity and reduce condensation. In the attic space a curtain of spun polyolefin air barrier (Tyvek) has been added to create an environmental separation between the pool side of the building and the remaining area. This curtain, unfortunately, also serves to limit cross ventilation and greatly lowers the effectiveness of the ventilators.

Swimming pool area with suspended ceiling and drapery.

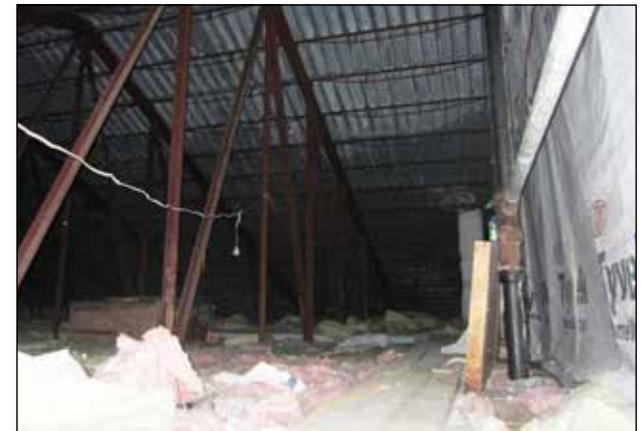
Attic space over gymnasium with Tyvek divider curtain.

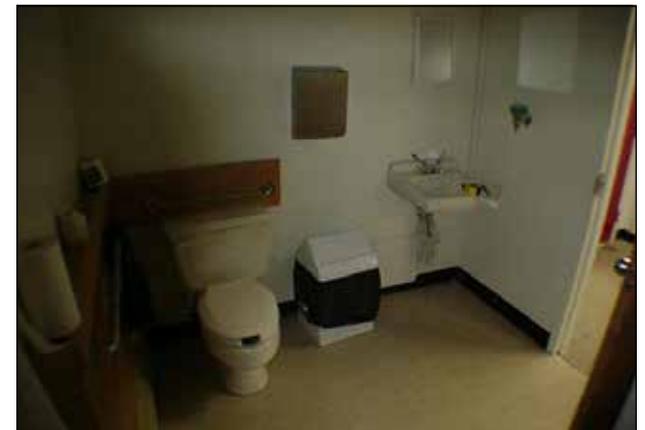
Supposed barrier-free washroom.

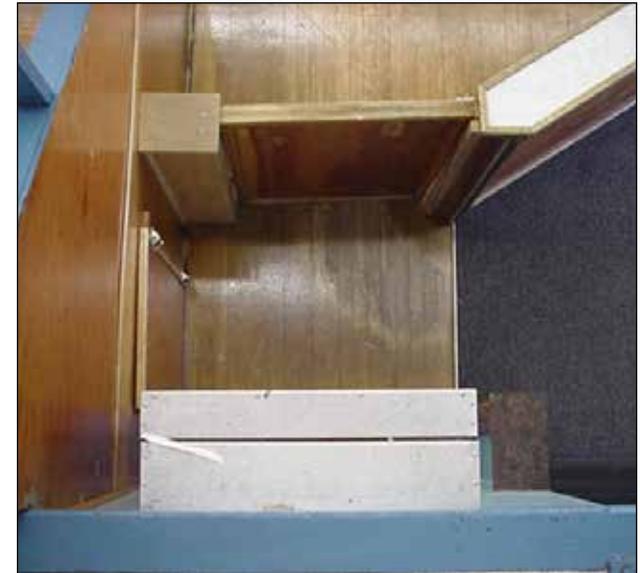
Non-accessible gate between gymnasium and entrance area.

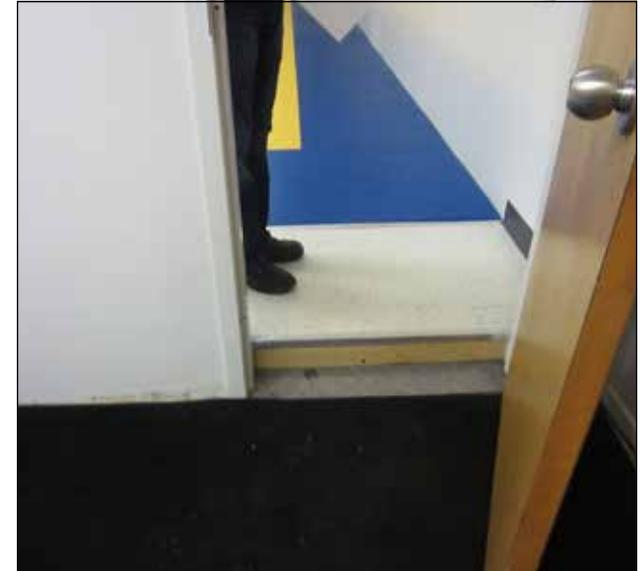
High threshold at the entrance to the Judo room.

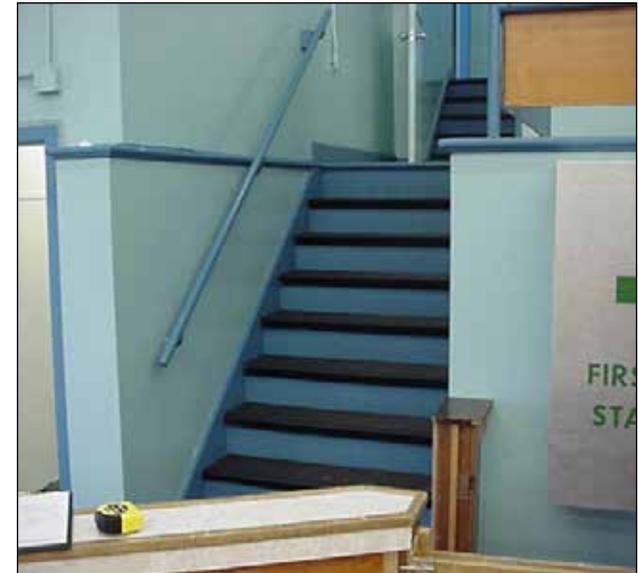
Sole access to exit from the all mezzanine areas.

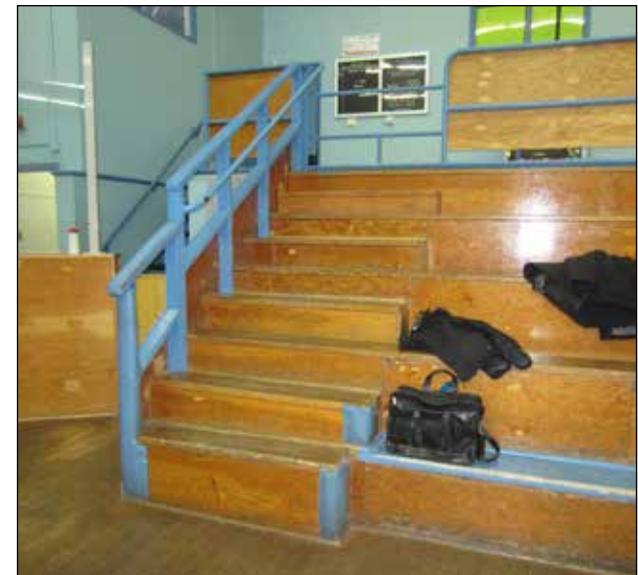
There are many other NBCC infractions throughout the building, especially as it relates to stairs and guards, much of which has previously been discussed in this report. The bleachers are also completely non-compliant as there is only one aisle, the riser steps exceed the 200 mm NBCC maximum and the locations of each riser step in the aisle are not visually distinct from the cross-aisle approach. As well, none of the bleacher guards comply with NBCC requirements.

Bleacher stepped aisle and seating area.

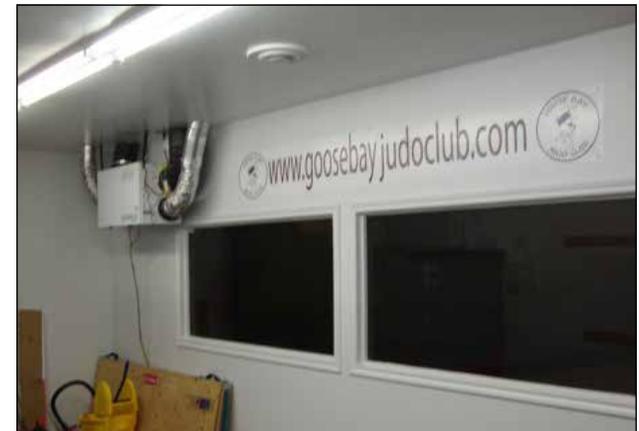
Residential-quality HRV in the Judo room extension.

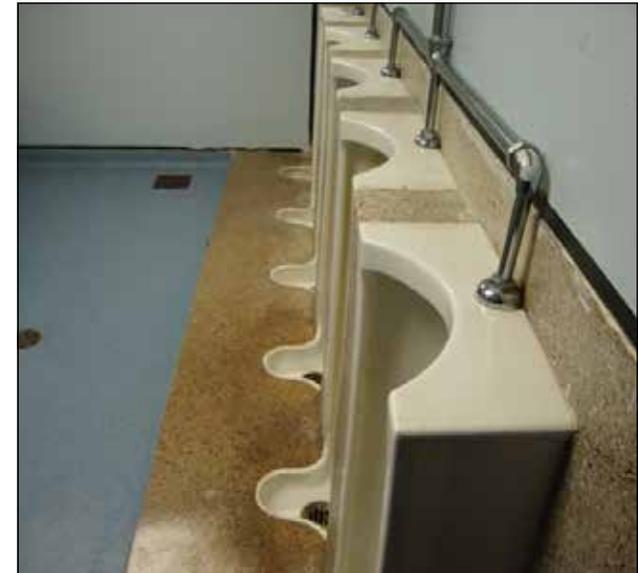
Vintage floor-mounted urinals with terrazzo surround.

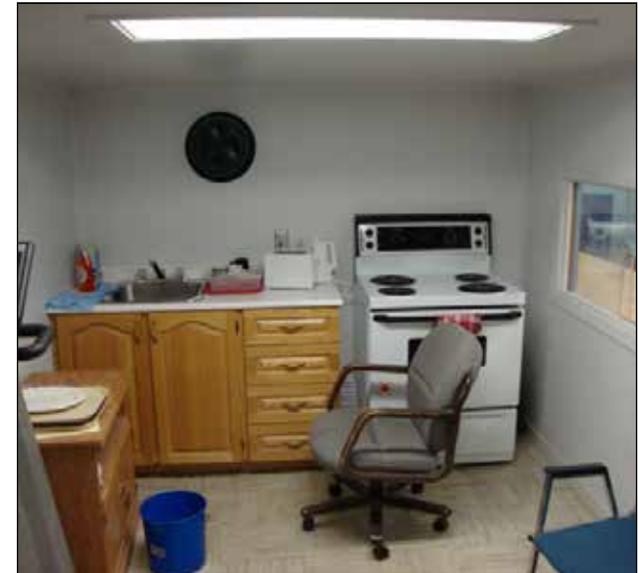
In the mezzanine kitchen area there is a typical residential-quality range/oven combination but there is no ventilation provided whatsoever. If this were a new building, the Fire Commissioner's office would require that a NFPA approved stainless steel exhaust hood with integral fire suppression be installed in a kitchen or canteen area with an open range.

Un-vented range in mezzanine kitchen/canteen area.

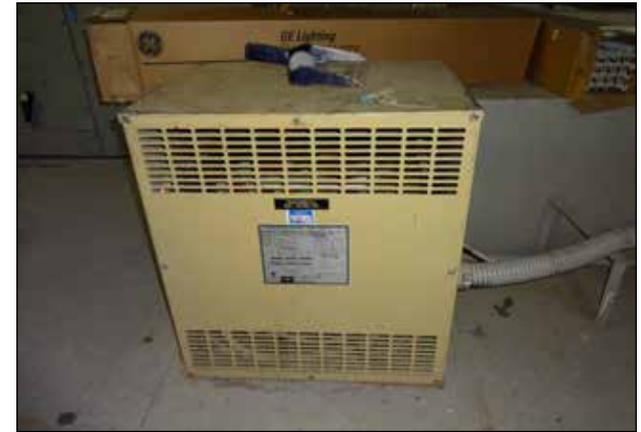
- The main service entrance board is in poor condition.
- The main electrical service entrance and distribution equipment is located in the mezzanine level mechanical room, which contains the aquatics area's air handling equipment.
- The main electrical room contains two dry-type transformers and is not ventilated, which will cause overheating. The transformers were very dirty and noisy.

Typical floor-mounted transformer.

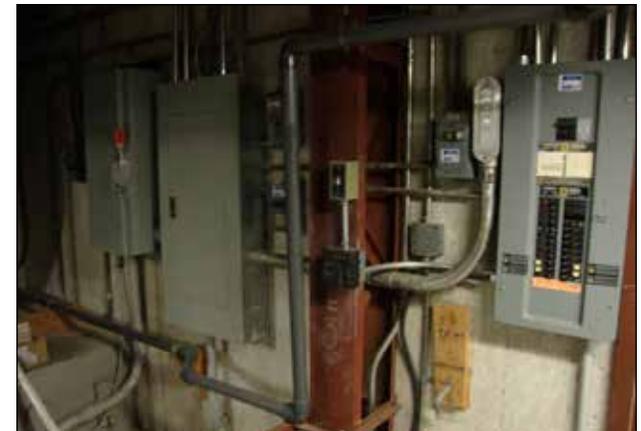
Service entrance and main distribution panels.

If the Labrador Training Centre is intended for long-term use, all of the primary 347/600 volt panel boards and feeders and the secondary 120/208 volt distribution sub-panel boards and wiring would have to be replaced in order to rectify the issues noted above. Some of the conduit could be re-used where appropriate.

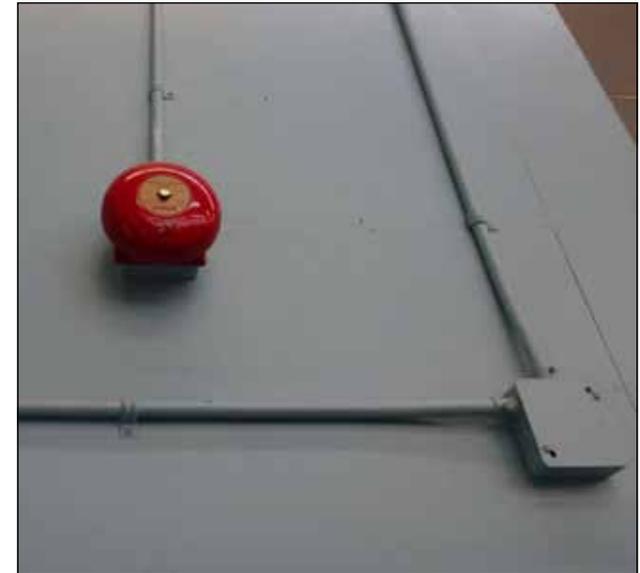
Fire alarm bell and typical surface-mounted conduits.

In general, the layout and coverage of the fire alarm system is inadequate and not in conformance with current National Building Code of Canada requirements.

Pull stations are required at all exits and there must be heat detectors installed in all storage rooms and stairwells. The alarm bells do not meet current standards and should be replaced with

combined visual strobes and audible alarms. The main panel should be replaced with an addressable type.

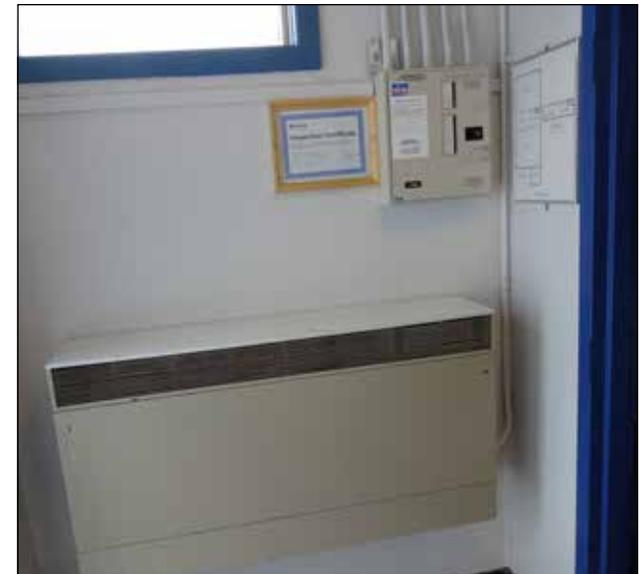
- Many spaces such as washrooms and corridors did not have any heat source installed.
- Many of the baseboard heaters exhibited mechanical damage and were filled with dust and debris.

Typical heater and fire alarm panel with surface conduit.

For continued operation of the facility all heaters should be thoroughly cleaned and badly damaged units should be replaced. New low-voltage thermostats and solid-state heater relays should also be installed to provide more accurate control of heat levels.

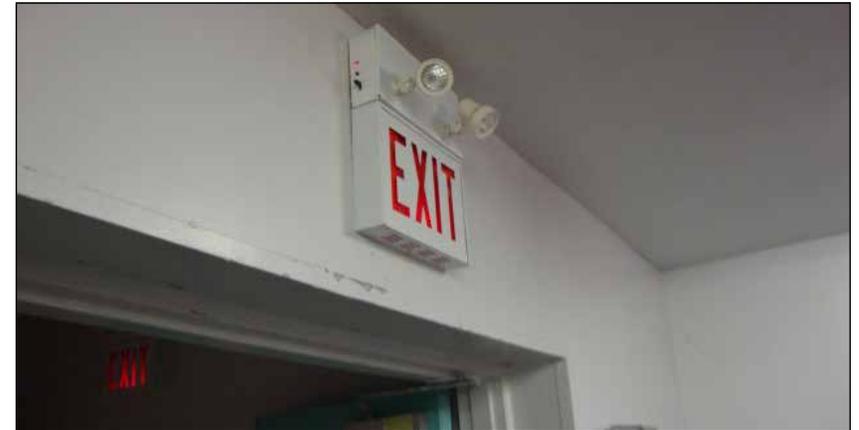
What exit lighting does exist throughout the facility is an older incandescent type. Exit lights are not located in all areas requiring such signage as per National Building Code regulations. A detailed review of exit lighting requirements should be undertaken and new signs added where necessary. Existing signage should be replaced with long-lasting LED fixtures.

Typical incandescent exit sign and emergency light combination.
